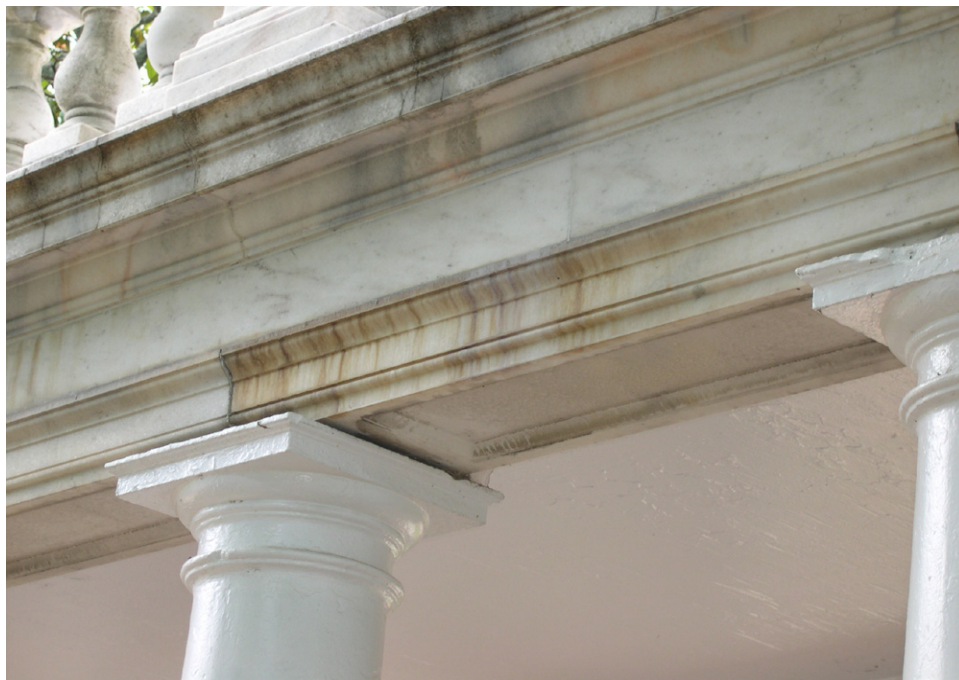
*East Colonnade, East Elevation. The marble entablature and soffit have been soiled and stained by rainwater run-off, originating in the terrace construction above. [JGWA, 2006]*
