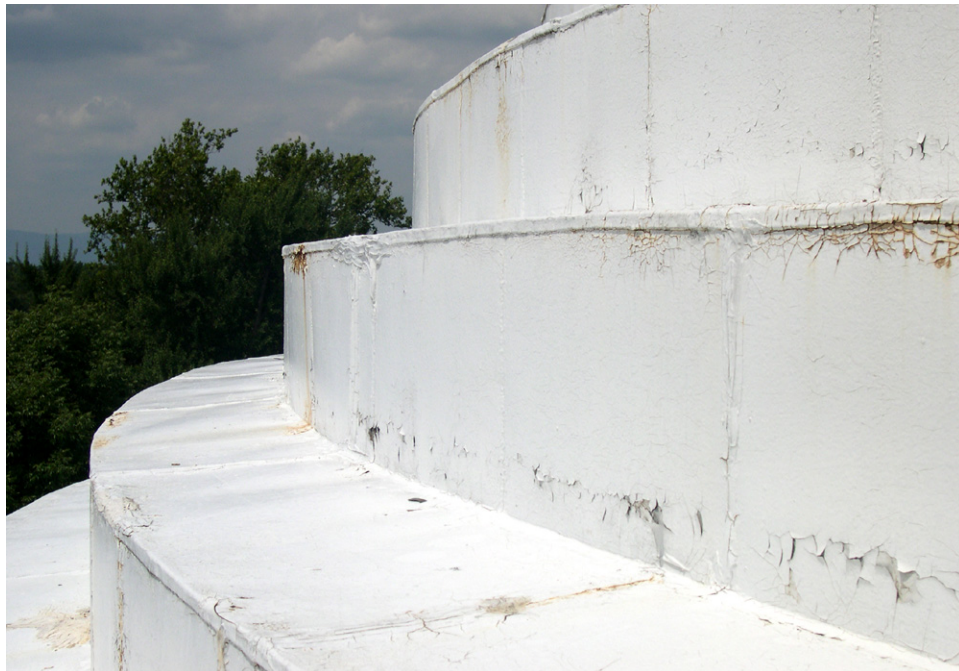
*Rotunda, Roof. The painted finish on the terne-coated sheet metal roofing of the dome is crazed and rust stained; this condition is pronounced on the north elevation. [JGWA, 2006]*
