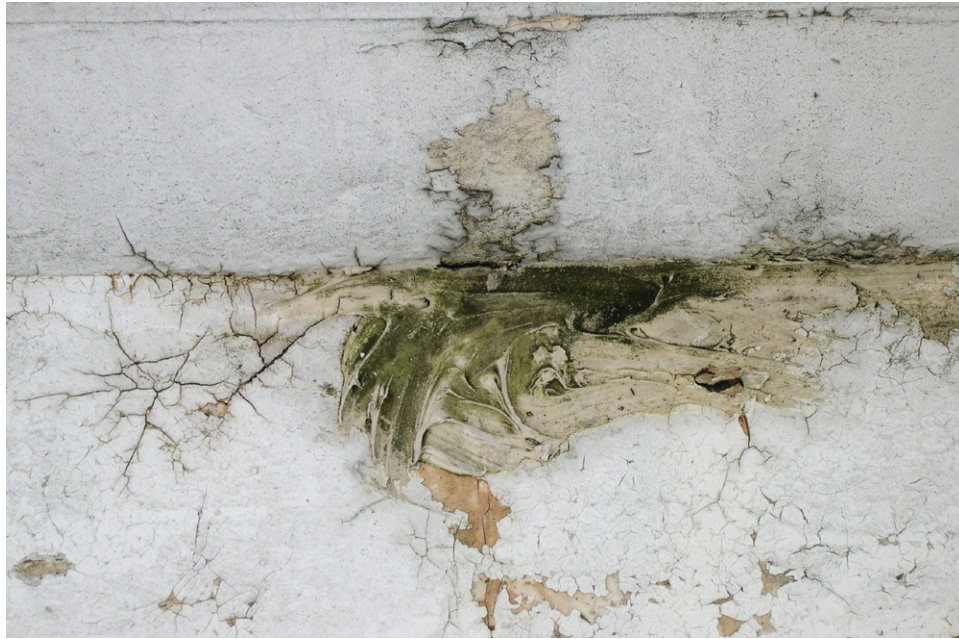
*Rotunda, Roof. Inadequate attempts have been made to cover areas of exposed sheet metal on the steps at the base of the dome with smeared sealant. The sealant is supporting the growth of algae.[JGWA, 2006]*

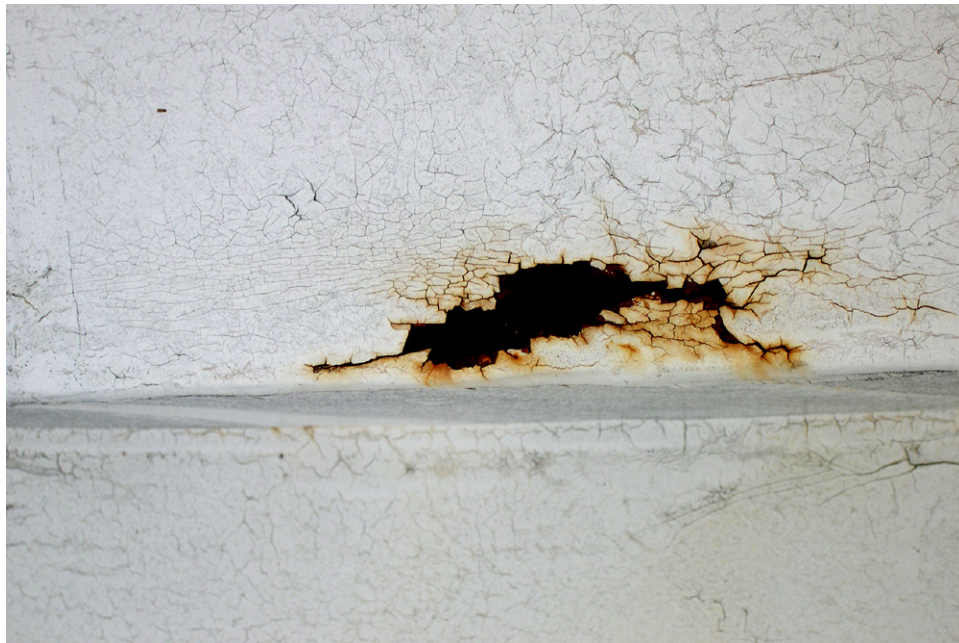
*Rotunda, Roof. The painted finish on the terne-coated roofing of the dome is crazed and peeling; the underlying sheet metal is rusting through. [JGWA, 2006]*
