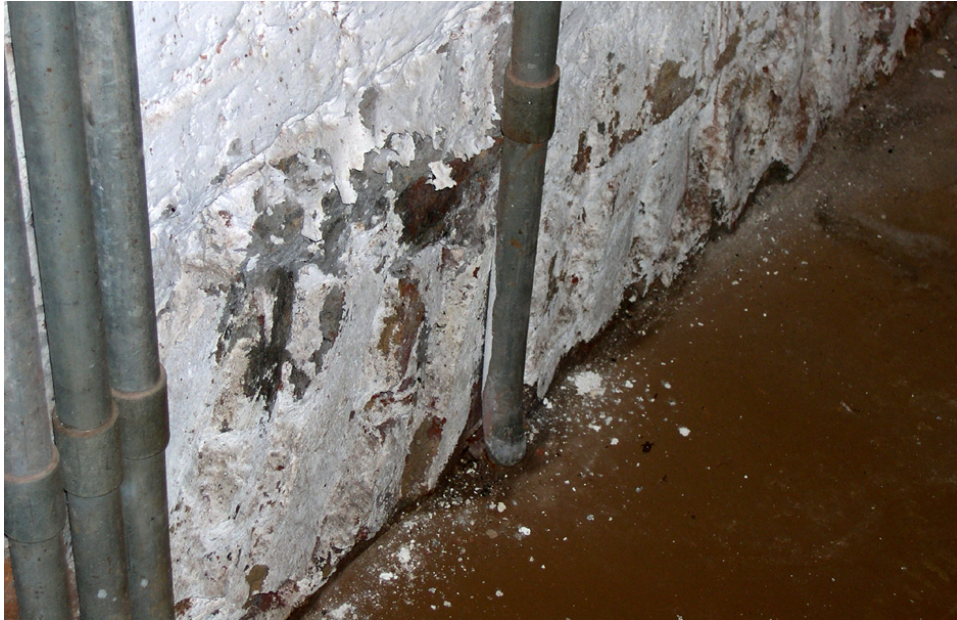
*There is rising damp in the masonry construction of the north and east walls of Mechanical Room (108). The painted wall finish is peeling, and efflorescence has formed on the masonry. [JGWA, 2006]*

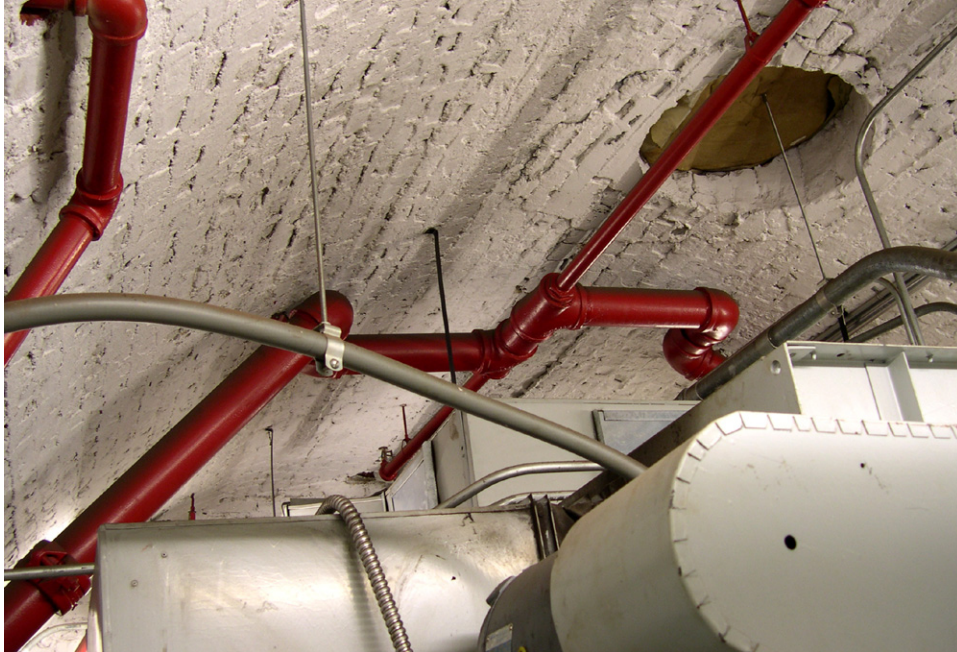
*The clearance space for mechanical, electrical, telephone, and sprinkler equipment in Mechanical Room (108) is inadequate and does not meet current building codes. [JGWA, 2006]*
