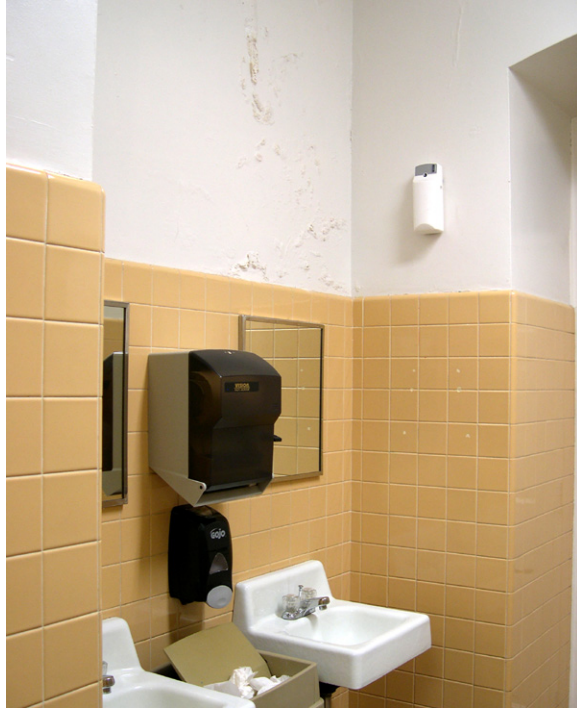
*Men's Toilet Room (T113),
looking northeast. [JGWA,
2006]*

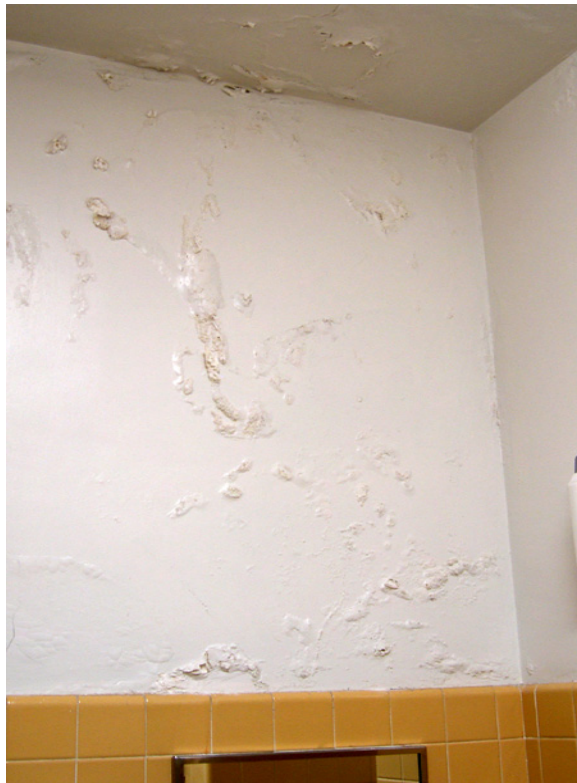
*The plaster wall and ceiling
surfaces in the northeast
corner of the Men's Toilet
Room (T113) are badly
blistered. The plaster is
friable, and the painted finish
is peeling as a result of water
infiltration. [JGWA, 2006]*
