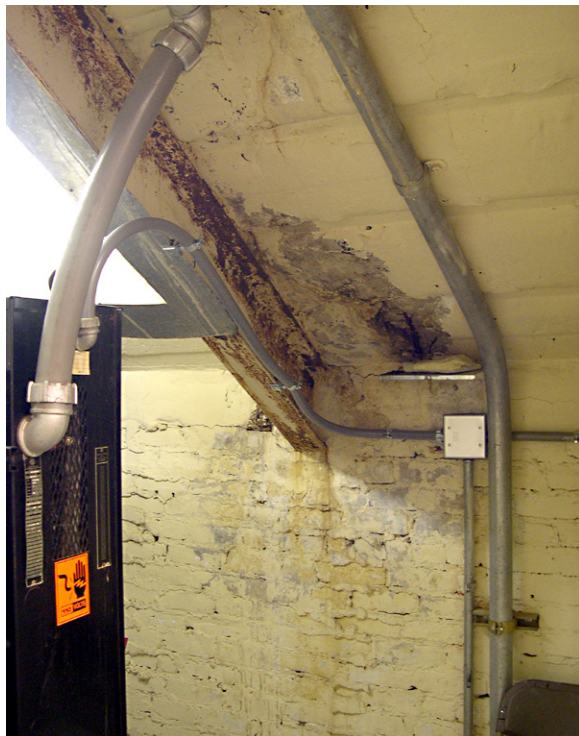
*The exposed steel beam supporting the sloped concrete ceiling of Elevator Machine Room (110A) has significant surface rust. The rust is more advanced at the beam's bearing point in the north wall. Galvanized sheet metal and acrylic glazing have been installed above the elevator machinery to protect the equipment from water infiltration occurring in the north portico steps above. [JGWA, 2006]*
