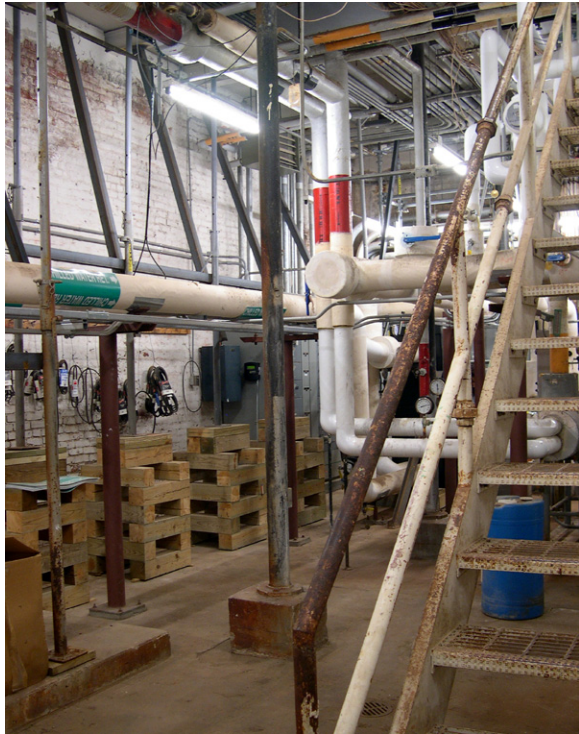
*Generations of temporary shoring have been introduced in the Mechanical Room beneath the north portico to support the ceiling and terrace construction above. [JGWA, 2006]*

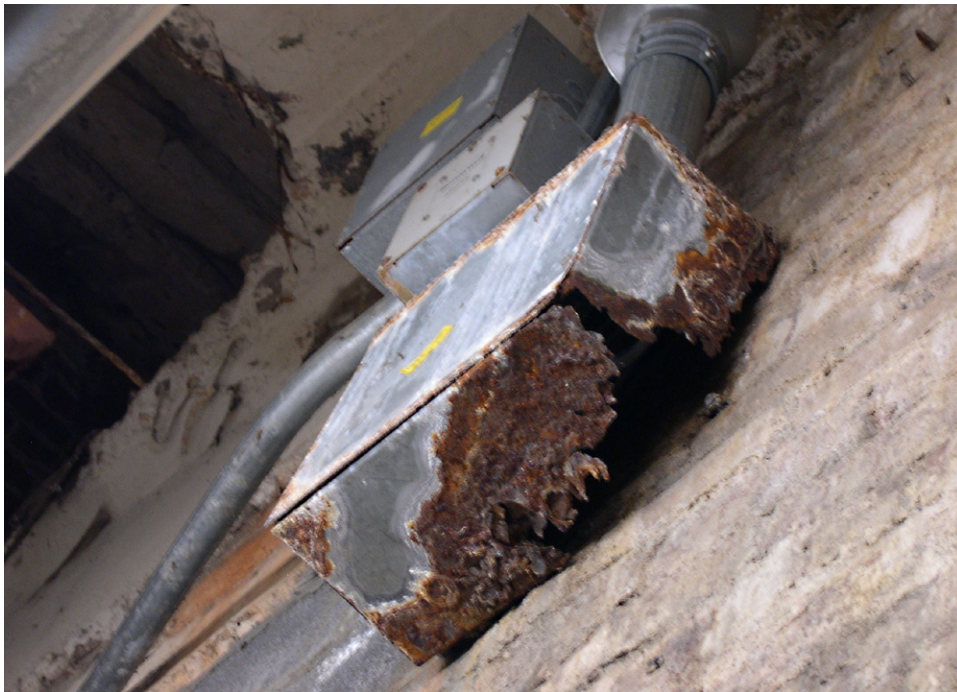
*Significant problems with water infiltration in the Mechanical Room beneath the north portico have lead to advanced deterioration of equipment and fixtures. [JGWA, 2006]*
