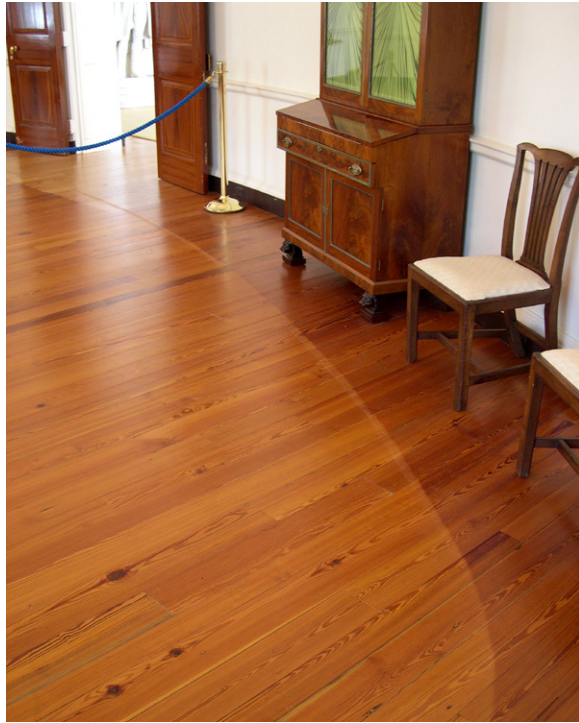
*The floor finish in the President's Reception Room (Upper West Oval Room 201) is discolored as a result of UV degradation. This was made apparent by the removal of the large oval rug that was located in the center of the room. [JGWA, 2006]*

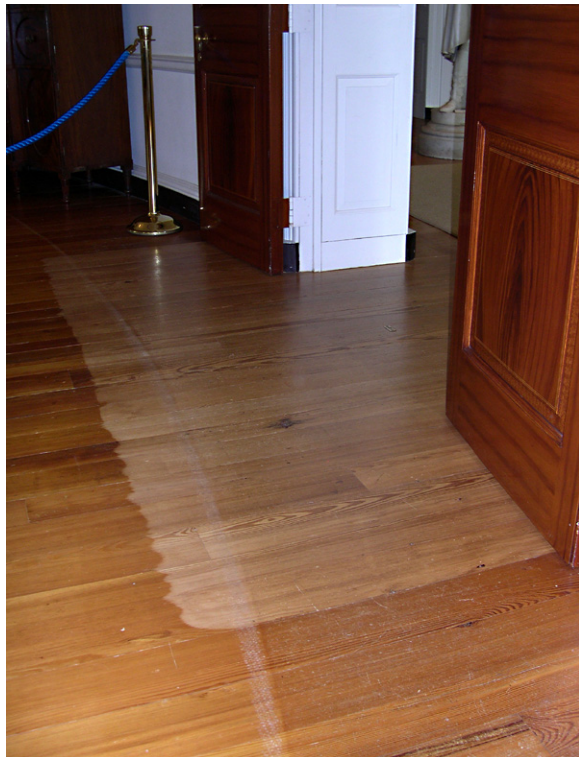
*Floor sanding in the Center Hall (C202/C203) was continued through the east entry of the President's Reception Room (Upper West Oval Room 201). This refinishing work and the perimeter abrasion from a large oval rug have caused discoloration and uneven wear in the heart pine flooring. [JGWA, 2006]*
