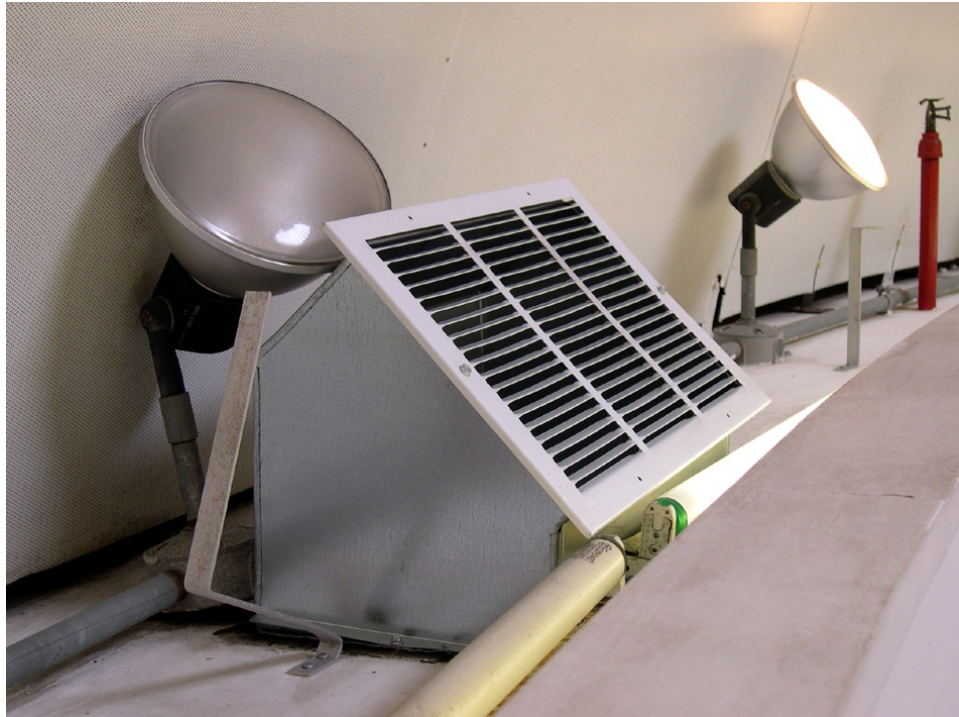
*Several of the perimeter spotlights at the base of the dome are not illuminated. Others have been removed or displaced by the installation of HVAC grilles. [JGWA, 2006]*

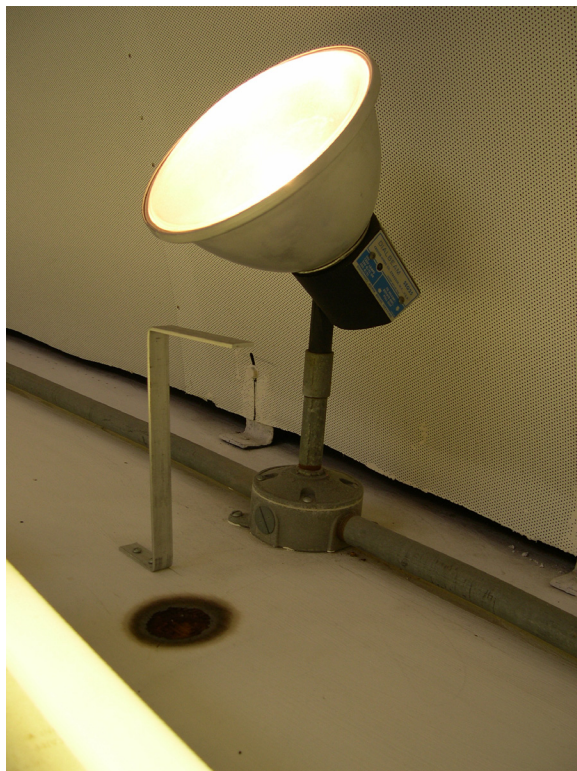
*Metal brackets were retrofitted beneath the high temperature spotlights at the base of the dome to prevent the fixtures from dropping and charring the plywood shelf on which they are mounted. [JGWA, 2006]*
