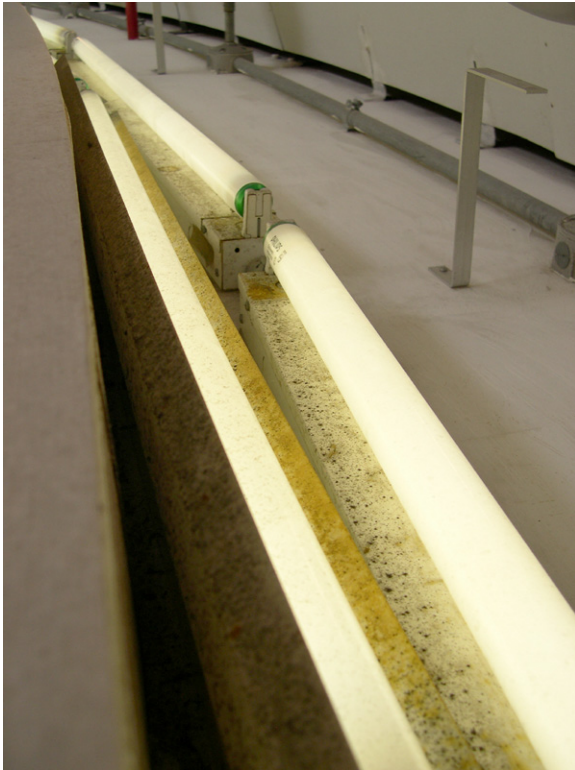
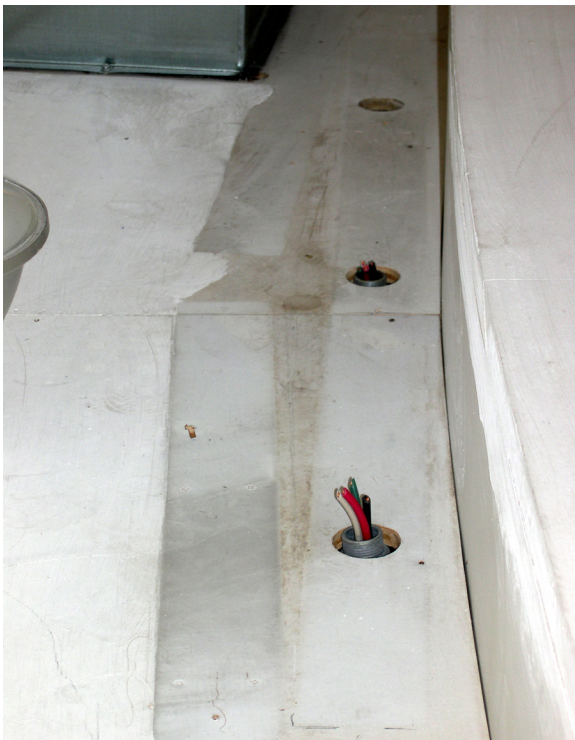
*The fluorescent strip lighting fixtures at the base of the dome were removed in December 2006 as part of the mold remediation project. Exposed conductors protruding from conduit remain; these conductors may present an electrical shock hazard. [JGWA, 2006 (top), 2007 (bottom)]*
