ARCHITECTURAL DESCRIPTION

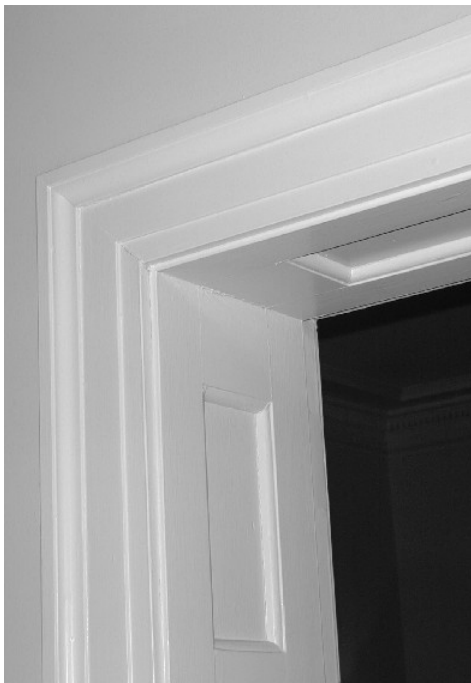
jamb of the first-story main room when the pocket door was removed (left).

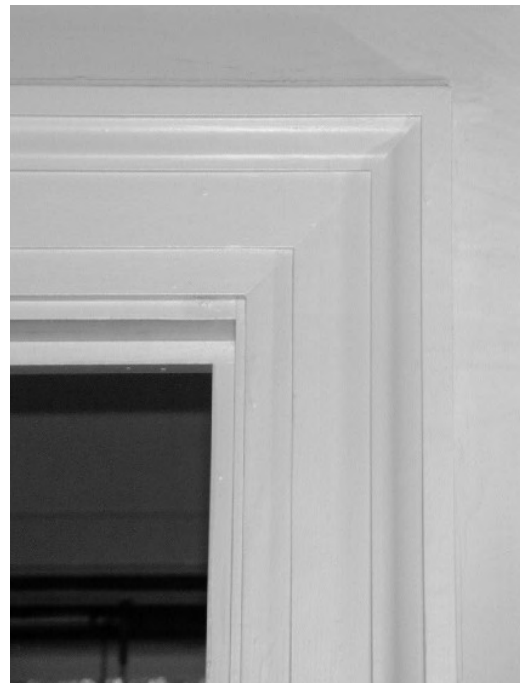
The doorway opening at the main first-story room has traditional mitered casings and backbands (right).

The room's door casings match those of the other first-story main rooms. They are traditional two-stage casings with a backband, mitered at the top corners, with small plinths at the bottom where the casing and baseboard meet. The baseboard is similar to that found in the main hall and other first-story rooms, but has a slightly different cap. The outlets in this room are located in the baseboard, and the room is lit by table lamps.
