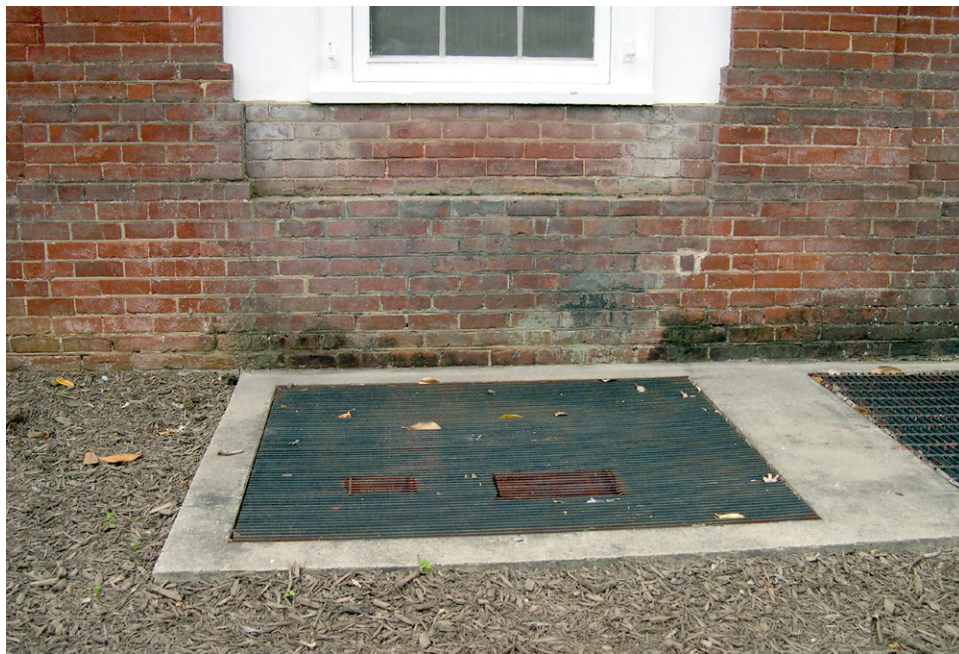
*Northeast Wing, North Elevation. The painted surfaces have chalked and stained the brickwork. There is dark biological staining on the brick near the rusted areaway grates. [JGWA, 2006]*
