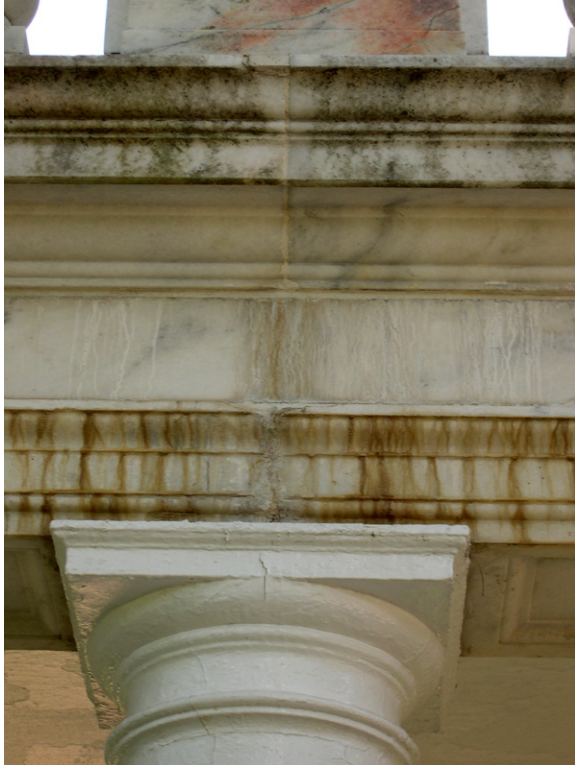
*West Colonnade, West Elevation. There are lime-run (calcium carbonate) deposits at the vertical joints in the marble entablature, and rust colored staining on the architrave. This deterioration has resulted from water percolating through the terrace construction above. [JGWA, 2006]*
