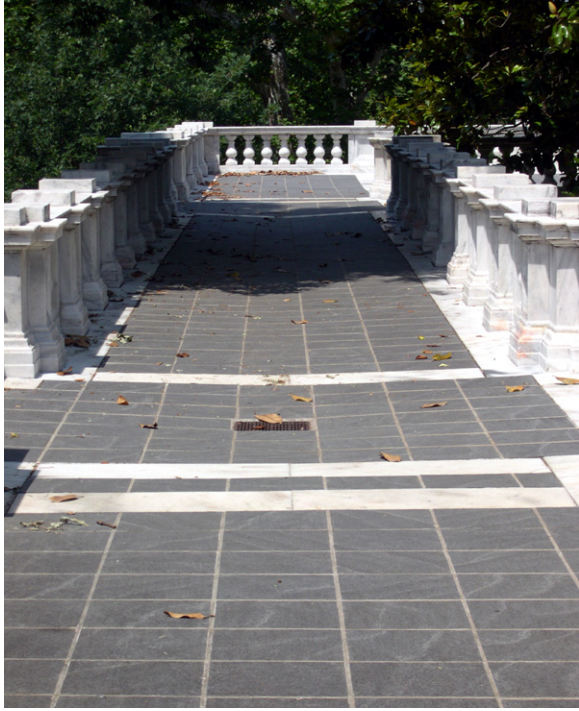
*West Terrace. Debris from the magnolia trees accumulates on the terrace. [JGWA, 2006]*

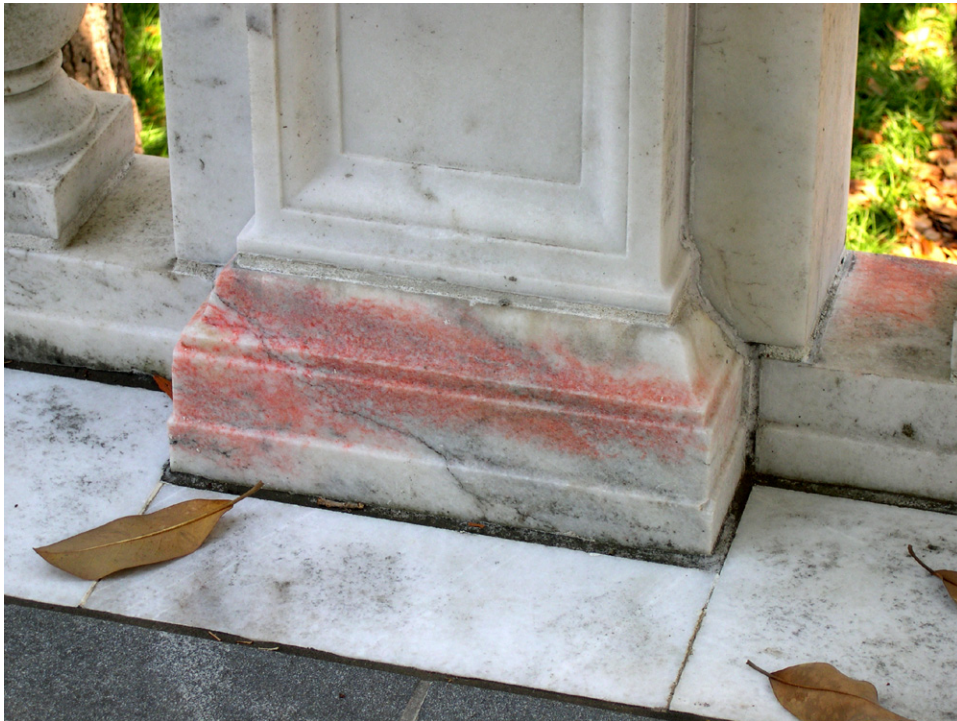
*West Terrace. There is vivid orange “staining” along the bottom rails of the marble balustrades; this appears to be subsurface biological growth. [JGWA, 2006]*
