Detection of loosened bolt- joint in braced steel frame structure based on impact hammer test

Abstract. This work performed an impact hammer test to track the loosened bolt joints in a braced steel frame structure. The measured frequency response functions (FRFs) data in the neighborhood of the first resonance frequency are extracted to estimate the proper orthogonal decomposition (POD) and proper orthogonal mode (POM). Two damage cases are handled in evaluating the performance of bolted joint in the braced steel frame structure.

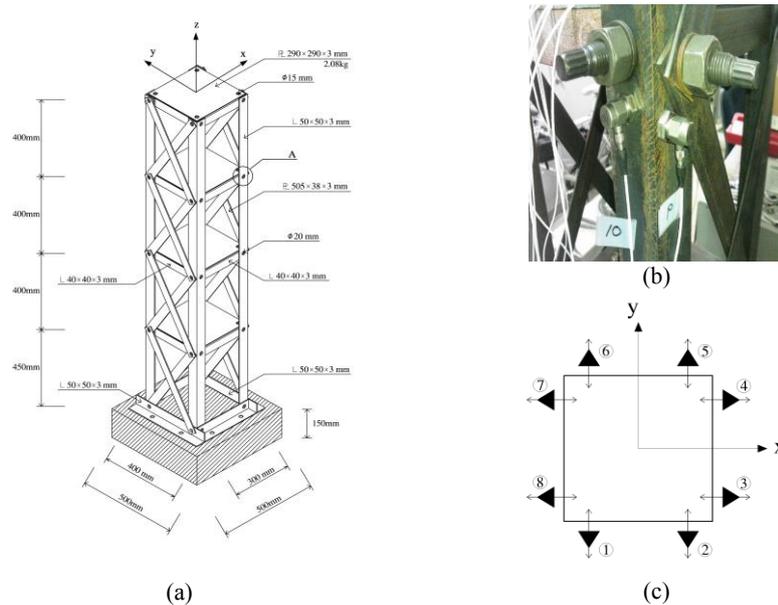
Fig. 1. A steel frame scale-model structure and installed accelerometers: (a) a steel frame structure model, (b) bolt joint and installed accelerometers to amplify the region A in Fig. 1(a), (c) x and y measurement directions by installed accelerometers.

An experiment to evaluate the joint tightness related with the lateral strength was performed in a four-story, one-bay by one-bay steel frame scale-model structure, shown in Fig. 1(a). A photograph shows the bolting joint of braced frame structure in Fig. 1(b) and the accelerometers as measurement sensors are installed as shown. The four vertical columns were comprised of continuous steel angles L50×50×3 in height and were bolted to a concrete foundation with dimensions of $b \times w \times t = 500 \times 500 \times 150\text{mm}$. The concrete foundation consists of four steel flanges bolted to each column, and the column was fastened to a massive concrete foundation. Four steel shim sheet squares represented the slab and measured approximately $290 \times 290 \times 3\text{mm}$ and 2.08kg , and were placed on the flanges of the steel beams. Cross bracing was externally added within each story along two faces. All cross bracing members were made using $38 \times 3\text{mm}$ wide steel strips, each measuring approximately 505mm in length. The bolts were tightened by torque wrench. The torque is a measure of how much a force acting on an object causes that object to rotate and is measured in Newton-meter ($\text{N} \cdot \text{m}$). All bolting joints at the initial state were tightened in the torque of $60\text{N} \cdot \text{m}$. If the torque is less than $60\text{N} \cdot \text{m}$, the bolting joint should be loosened and the lateral strength should be deteriorated.

Two accelerometers in the perpendicular directions at each corner column were installed as shown in Fig. 1(c) and measured the FRF in the indicated directions. The accelerometer set is composed of eight accelerometers at each floor. An impact

hammer was used to excite the frame and hit the midspan point of the beam at the fourth floor in the bracing direction. The impact was taken in the positive y-direction on the x-y plane as shown in Fig. 1(c). The response measurement was carried out using an accelerometer set. Ten measurement channels were utilized for data acquisition, including a channel for the impact hammer and a reference channel. Four different experiments were repeated in changes of the accelerometer set on each floor. The experiment was conducted using DYTRAN model 3055B1 uniaxial accelerometers along with a miniature transducer hammer Brüel & Kjaer model 8204 to excite the system. The data acquisition system was a DEWETRON model DEWE-43.

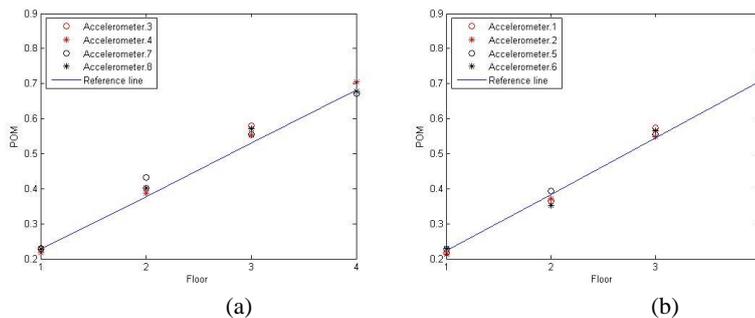
Fig. 2. Damaged steel frame with the bolting looseness at the bracing joint of the second floor: (a) x-direction, (b) y-direction

The POMs corresponding to the first POV extracted from the FRF data are shown in Figs. 2 and 3. They represent the plots in the impact direction (y-direction) and its perpendicular direction (x-direction). It is shown that the POM variation in the x-direction from the reference line is larger than in the y-direction due to the bolt loosening at bracing joint end. The plots in Figs. 2 and 3 exhibit that the damage exists at the location of bolting looseness to represent the large POM variation, respectively.

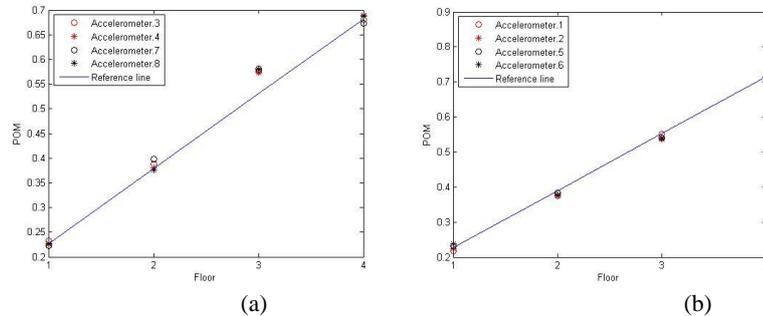
Fig. 3. Damaged steel frame with the bolting looseness at the bracing joint of the third floor: (a) x-direction, (b) y-direction
